Contract #: 04-0120F4Cty: SF/ALA Rte: 80 PM: 13.2/13.9File #: 13.28**WELDING INSPECTION REPORT****Resident Engineer:**Pursell, Gary**Address:** 333 Burma Road**City:** Oakland, CA 94607**Report No:** WIR-008623**Date Inspected:** 17-Aug-2009**Project Name:** SAS Superstructure**OSM Arrival Time:** 1400**Prime Contractor:** American Bridge/Fluor Enterprises, a JV**OSM Departure Time:** 2230**Contractor:** Oregon Iron Works Clackamas, Or.**Location:** Clackamas, OR**CWI Name:** Steve Barnett, William Buck**CWI Present:** Yes No**Inspected CWI report:** Yes No N/A**Rod Oven in Use:** Yes No N/A**Electrode to specification:** Yes No N/A**Weld Procedures Followed:** Yes No N/A**Qualified Welders:** Yes No N/A**Verified Joint Fit-up:** Yes No N/A**Approved Drawings:** Yes No N/A**Approved WPS:** Yes No N/A**Delayed / Cancelled:** Yes No N/A**Bridge No:** 34-0006**Component:** Hinge-K Components**Summary of Items Observed:**

Summary of Items Observed: On this date, Caltrans Quality Assurance Inspector (QA) Clete Henke was present at Oregon Iron Works, Inc. (OIW) in Clackamas, OR for observation of fabrication of the Hinge K Pipe Beams and related activities including in process welding a

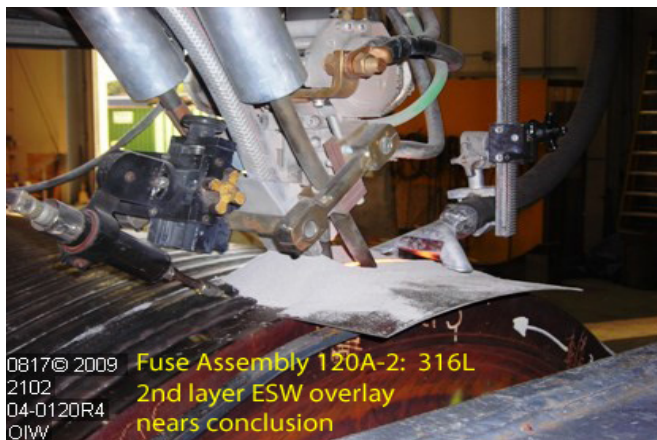
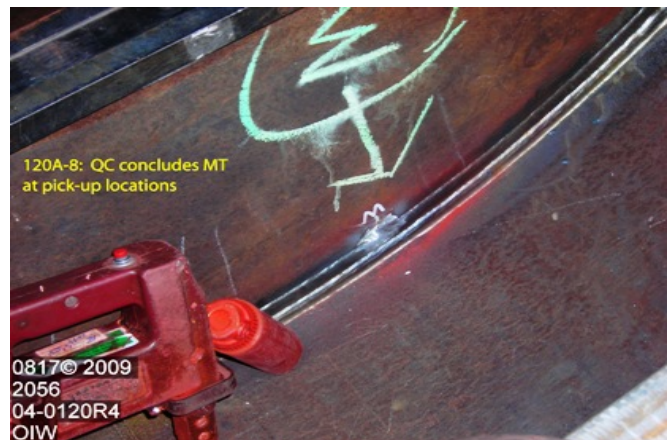
The QA Inspector intermittently observed OIW qualified welder Bounheune Savanh (WID S74) during in-process welding of Soudotape 316L stainless steel overlay to hinge k pipe beam fuse sub-assembly 120A-2. The weld joint is identified as 316L 2nd Layer. Mr. Savanh was observed welding in the flat position utilizing automatic electro slag welding (ESW) overlay process with a .5mm x 60mm Soudotape 316L stainless electrode, filler metal brand Soudotape class EQ316L automatic. The QA Inspector noted that 316L 2nd Layer was completed at about 1930 hours and 316L 3rd Layer was set up and initiated shortly thereafter. 316L 3rd Layer was in-process for the remainder of the shift. An OIW helper was observed assisting welder S74 during ESW activity. The QA Inspector observed OIW QC Inspector Steve Barnett regularly monitoring and recording the in process ESW parameters. The QA Inspector also intermittently observed in process welding parameters and determined that the ESW parameters (1200 amps, 25.7 volts, 267mm/min travel speed) and minimum preheat temperature of 70° F appeared to be in general compliance with the contract requirements and approved OIW Welding Procedure Specification (WPS) 7003.

The QA Inspector was contacted by OIW QC Inspector Steve Barnett and notified that he had completed QC Magnetic particle Testing (MT) and Visual Inspection (VT) of Partial Joint Penetration (PJP) weld joints WM3-12, WM3-13, WM3-14, WM3-15, WM3-16 & WM3-17 which are contained within the right hand (RH) half of Fuse assembly 120A-8 identified as a124-16. The referenced testing concluded QC NDT on the assembly prior to rough machining. The QA Inspector subsequently performed 100% VT & 10% MT verification at the locations noted above finding the cover passes to be in general compliance with contract documents. Please reference TL-6028 report for this date for details.
